Panel Contact Optimization

Thunderer Jetty, London, United Kingdom

Type
Parallel Motion Fenders

Reference 0170

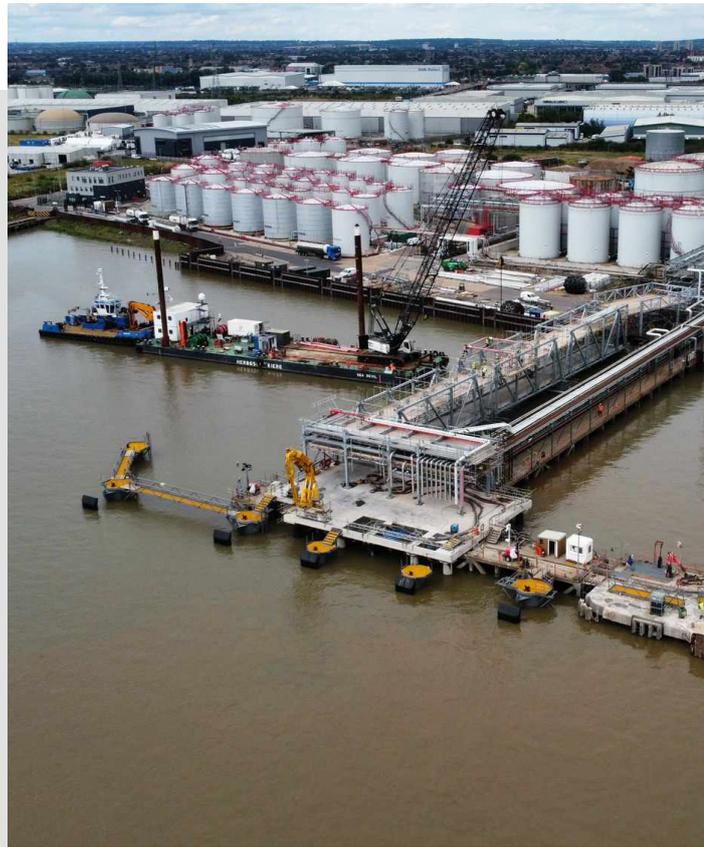
Secondly, there was the **complexity of working with these large PMFs.** For the former, the SFT sales and logistics teams worked thoroughly to meet the demanding schedule; for the latter, the contractor decided to assemble and install the fenders onto the dolphin' heads at a steel construction facility in the South of England and ship them out from there to the job site along the river.
